PINE RUN DAM
(PA 491)

NDI No. PA 00737
PennDER No. 43-55
SCS No. PA 491

PHASE I INSPECTION REPORT
NATIONAL DAM INSPECTION PROGRAM

Pine Run Dam (PA 491), Mercer County, Pennsylvania
NDI No. PA 00737, PennDER No. 43-55, SCS No. PA 491
Pine Run
Inspected 8 and 10 December 1979

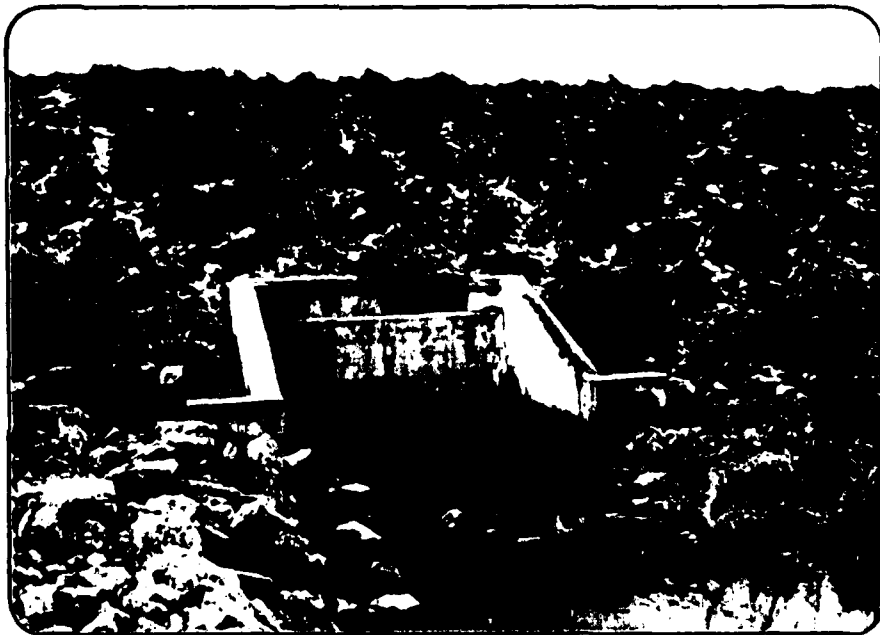
PHOTO 2. View of the Principal Spillway Outlet Structure

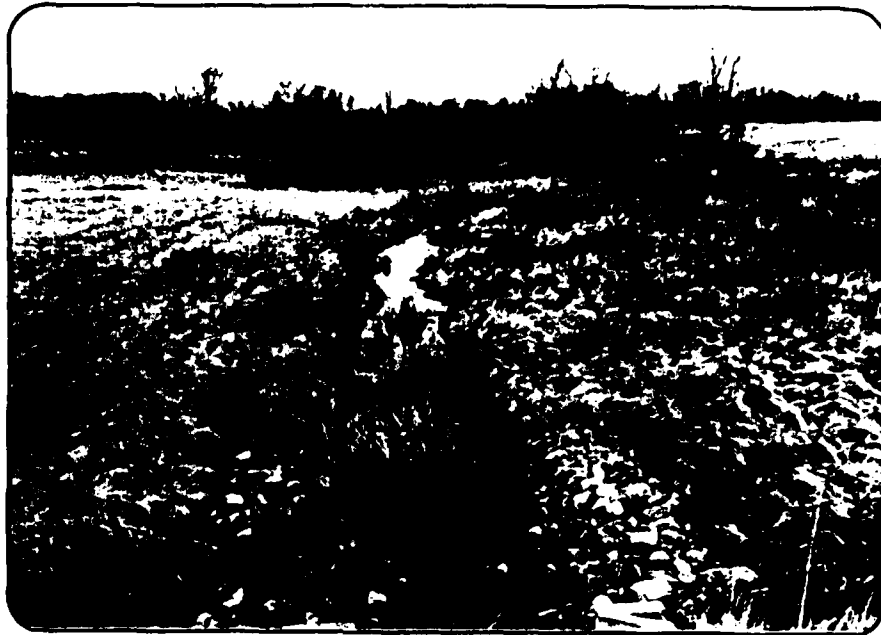
PHOTO 3. View of the Outlet Channel of the Principal Spillway
